National Register of Historic Places Registration Form

historic name Sheffer, Daniel, Farm
other names F-4-35

Sheffer, Daniel, Farm (F-4-35)

Frederick County, Maryland

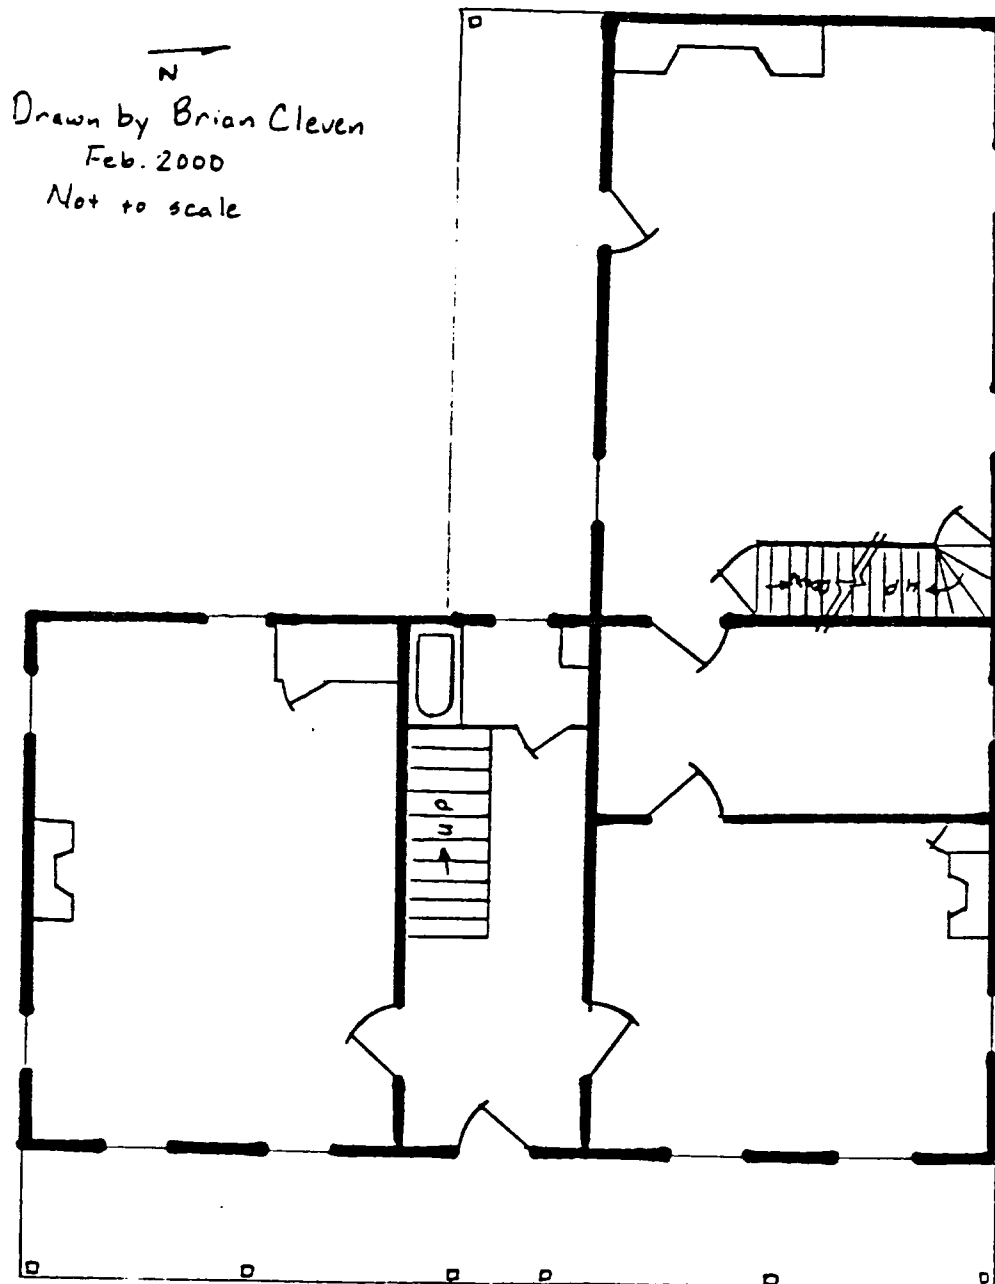
NATIONAL REGISTER OF HISTORIC PLACES
CONTINUATION SHEET
Sketch First Floor Plan

The interior of the house is asymmetrical in its layout. The main block contains a central hallway flanked by a parlor on either side. The north half of the house is divided into two unequal-sized rooms. The ornamentation in the hall and parlors includes molded wood baseboards and door and window surrounds. Each parlor contains an ornamental mantel that reflects the influence of the Greek Revival style. The dog-leg hall stairway features a slender turned newel post with a flat nob top, a wood balustrade with three-quarters round hand rail and square balusters, and ornamental acorn drops at the turnings. Scrollwork ornaments the open stringers. The area under the stairway at the end of the hall has been enclosed to make a bathroom. The walls and ceilings are plaster throughout, though many surfaces exhibit remnants of faded wallpaper.

The rear wing contains a kitchen on the first floor. The original cooking hearth has been enclosed by a wood box constructed of vertical beaded boards. Most of the finishes and cabinets in this area appear to date from the 1950s. An enclosed stair is located in the east end of the kitchen. This is the only access to the second floor of the rear wing. The unfinished basement also contains a large cooking hearth.

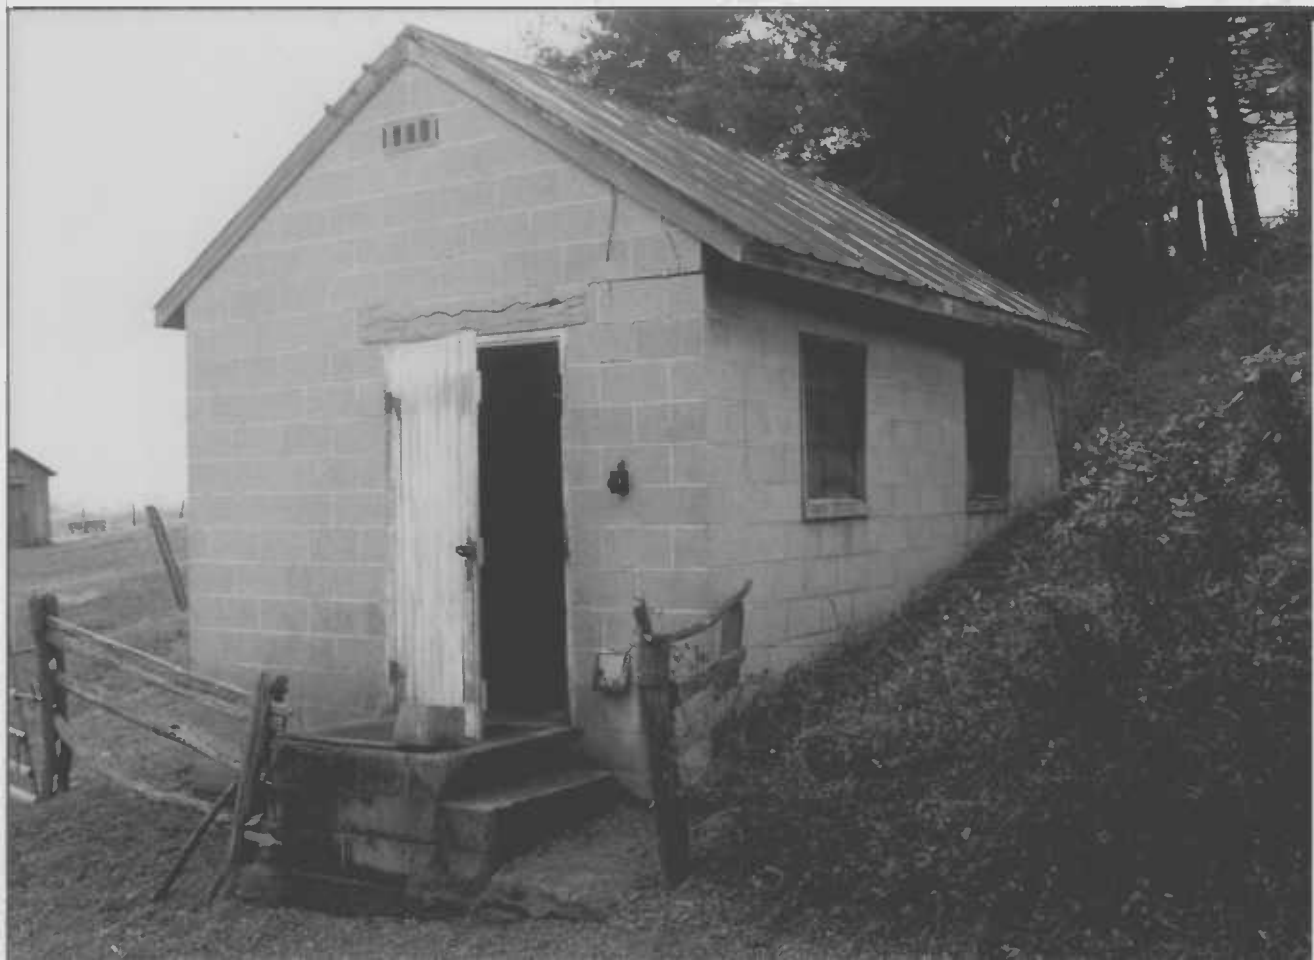
13 of 18

Milk house looking SE

A terra cotta silo, constructed ca. 1930, is located at the southwest end of the barn. A domed metal roof caps the silo. South of the barn is a rectangular, concrete block milk house. Constructed ca. 1930, this building features a vertical-board wood door on the north elevation and two windows on the east and west sides. The windows consist of six-light, metal-sash windows. The front gable roof is sheathed with standing seam metal.
